Manhole Inspection Summary

Manhole # S67I__003MH

Insp Date: **1/8/08 11:55 AM**

Location Address: **551 Dundalk Ave.**

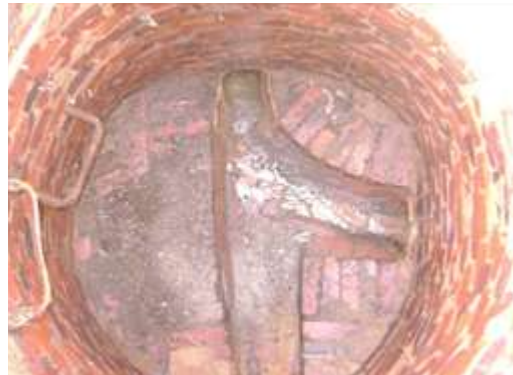
Top View

Comments **LOOKS LIKE 12-O PIPE IS FRACTURED VOID VISIBLE AT JUNCTION TO TROUGH. AFTER INSPECTING WITH CAMERA WE CONFIRMED THE BOTTOM OF THE CLAY PIPE IS BROKEN.**
